*Shijiazhuang CAPT Full Standard
Range of Steel TB Taper
Bushings – A **New** Choice
for Industrial Safety!*

SHIJIAZHUANG CAPT POWER TRANSMISSION CO., LTD.

C45 Steel High-Strength TB Taper Bushings – Your Safe Choice!

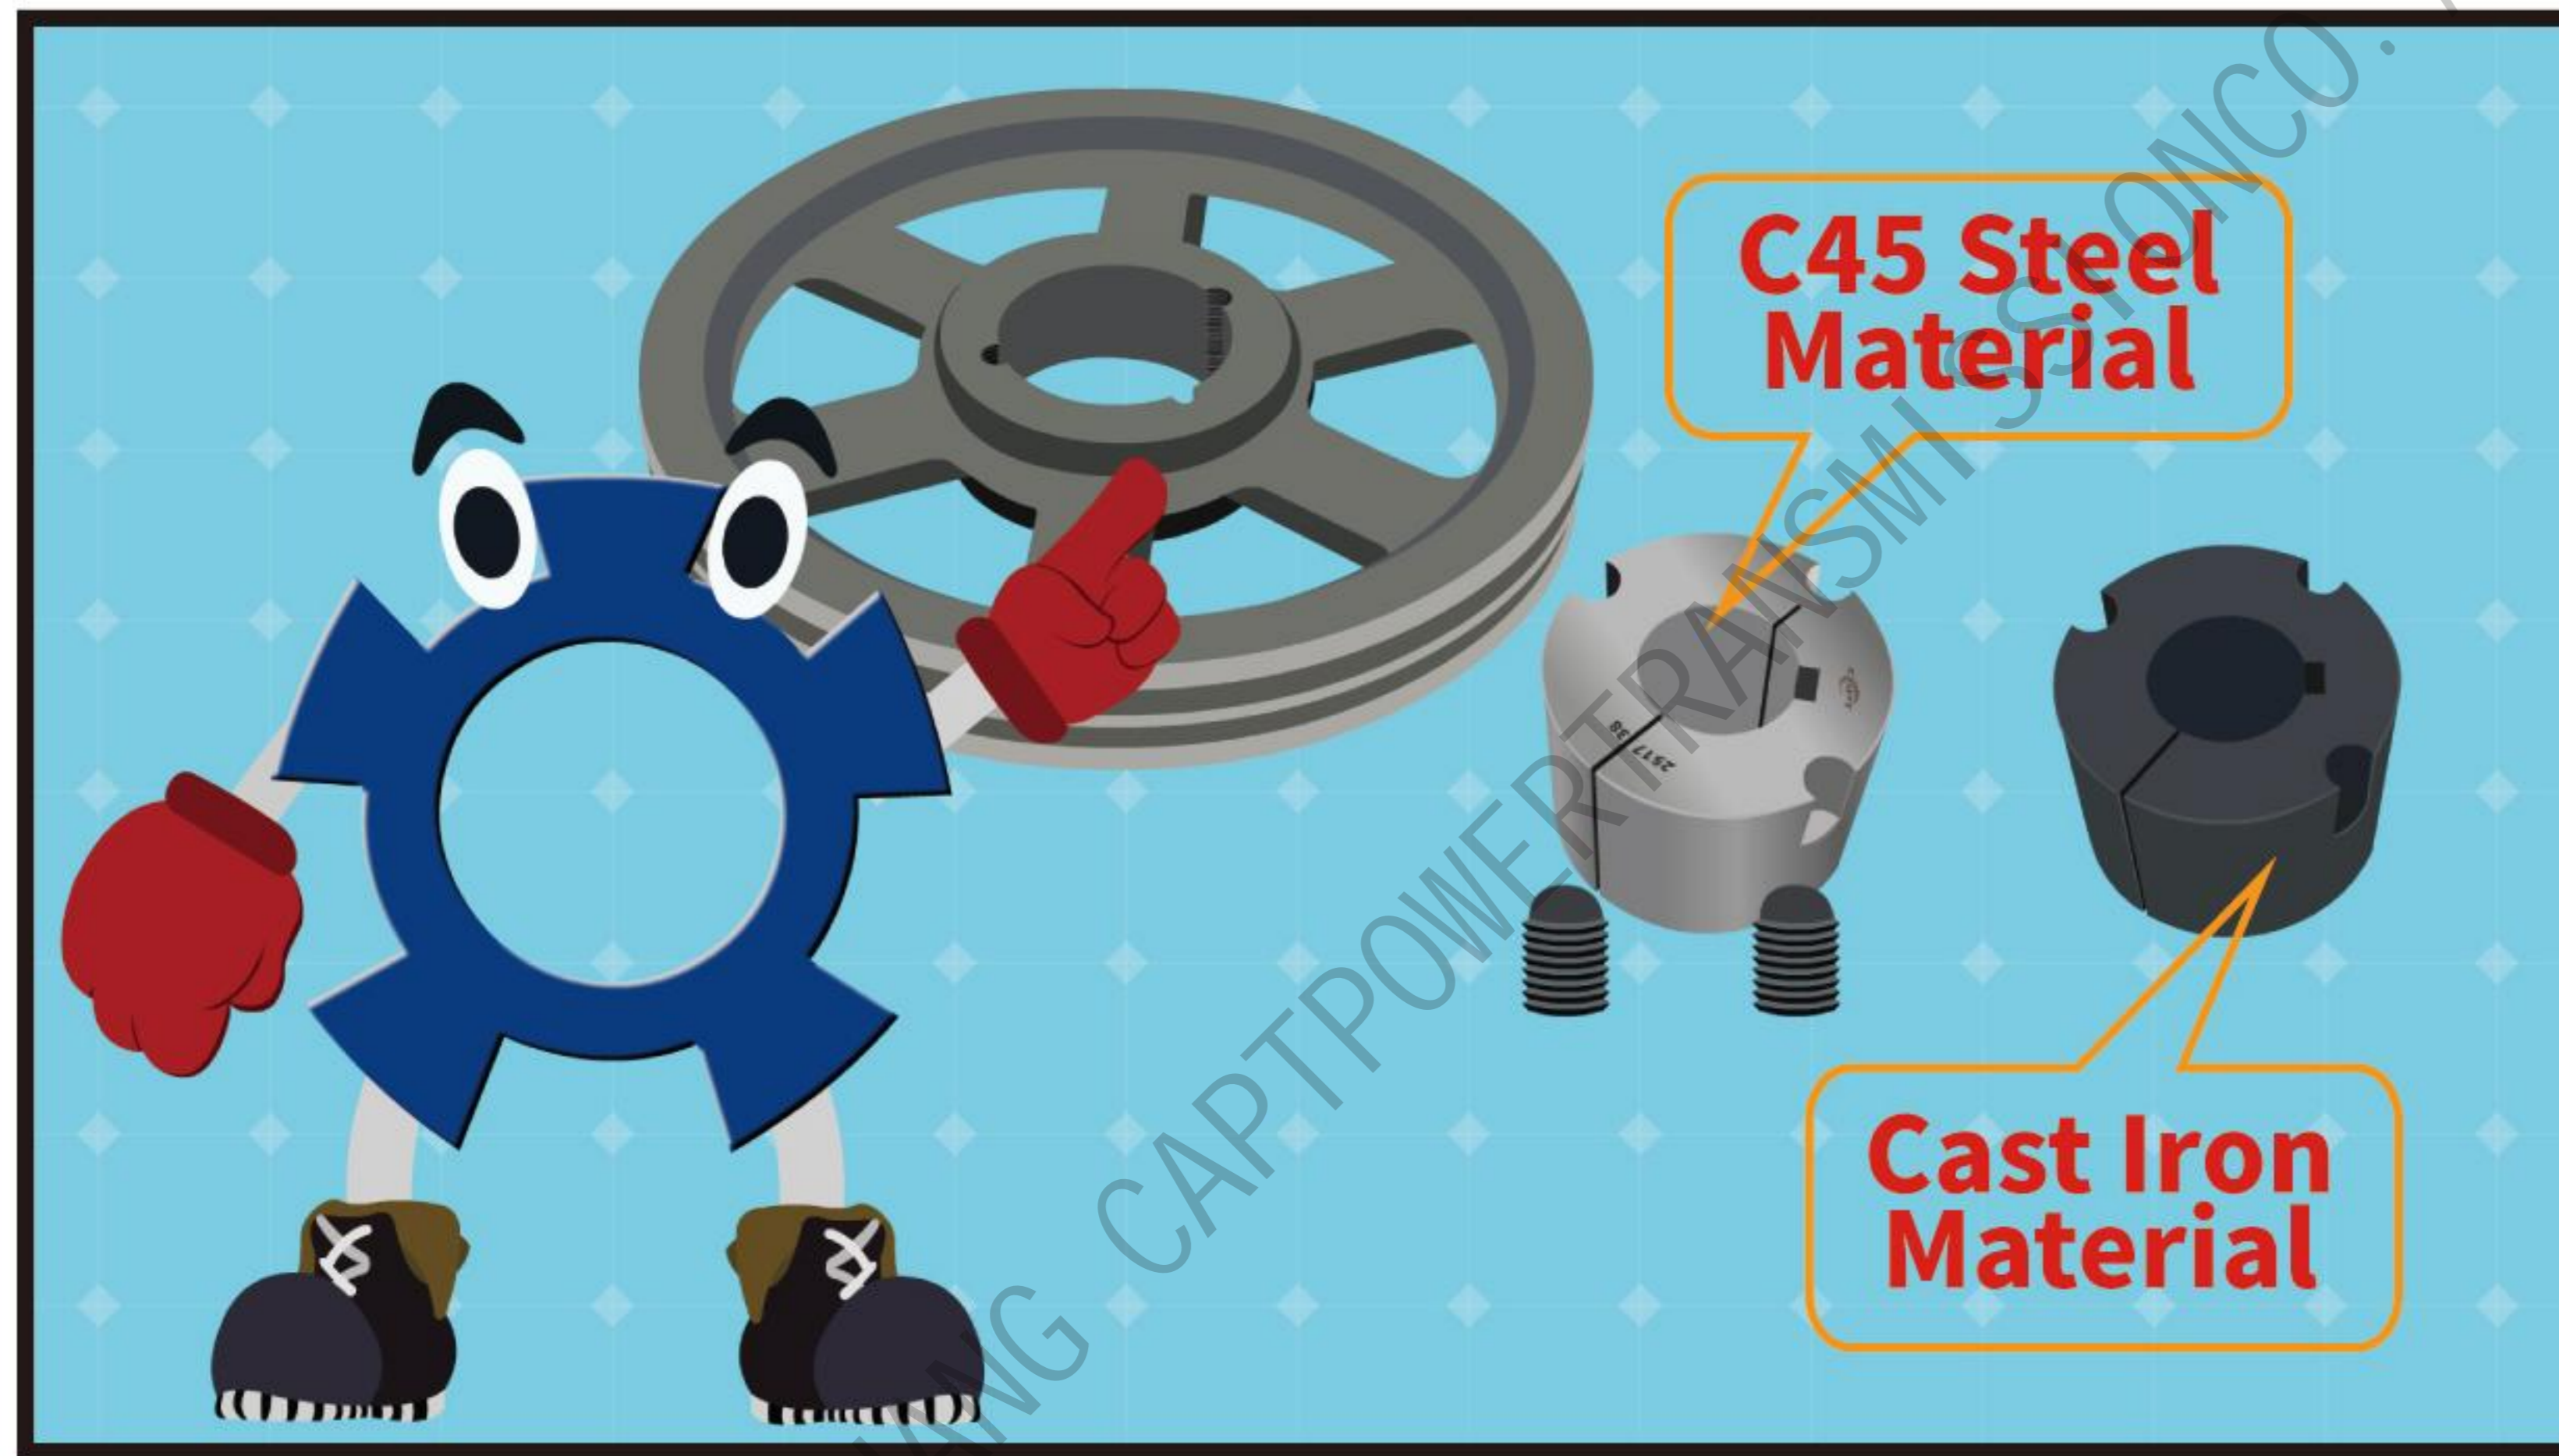
① TB taper bushings come in two types: high-strength and low-strength materials.

Classification	Tensile Strength	Strength Coefficient	Application Recommendation
C45	$\geq 600\text{Mpa}$	2.5	***
QT450	$\geq 450\text{Mpa}$	1.8	**
HT250	$\geq 250\text{Mpa}$	1.0	*
HT200	$\geq 200\text{Mpa}$	0.8	Reliability Issues

② Comparison of tensile strength between different bushing materials.

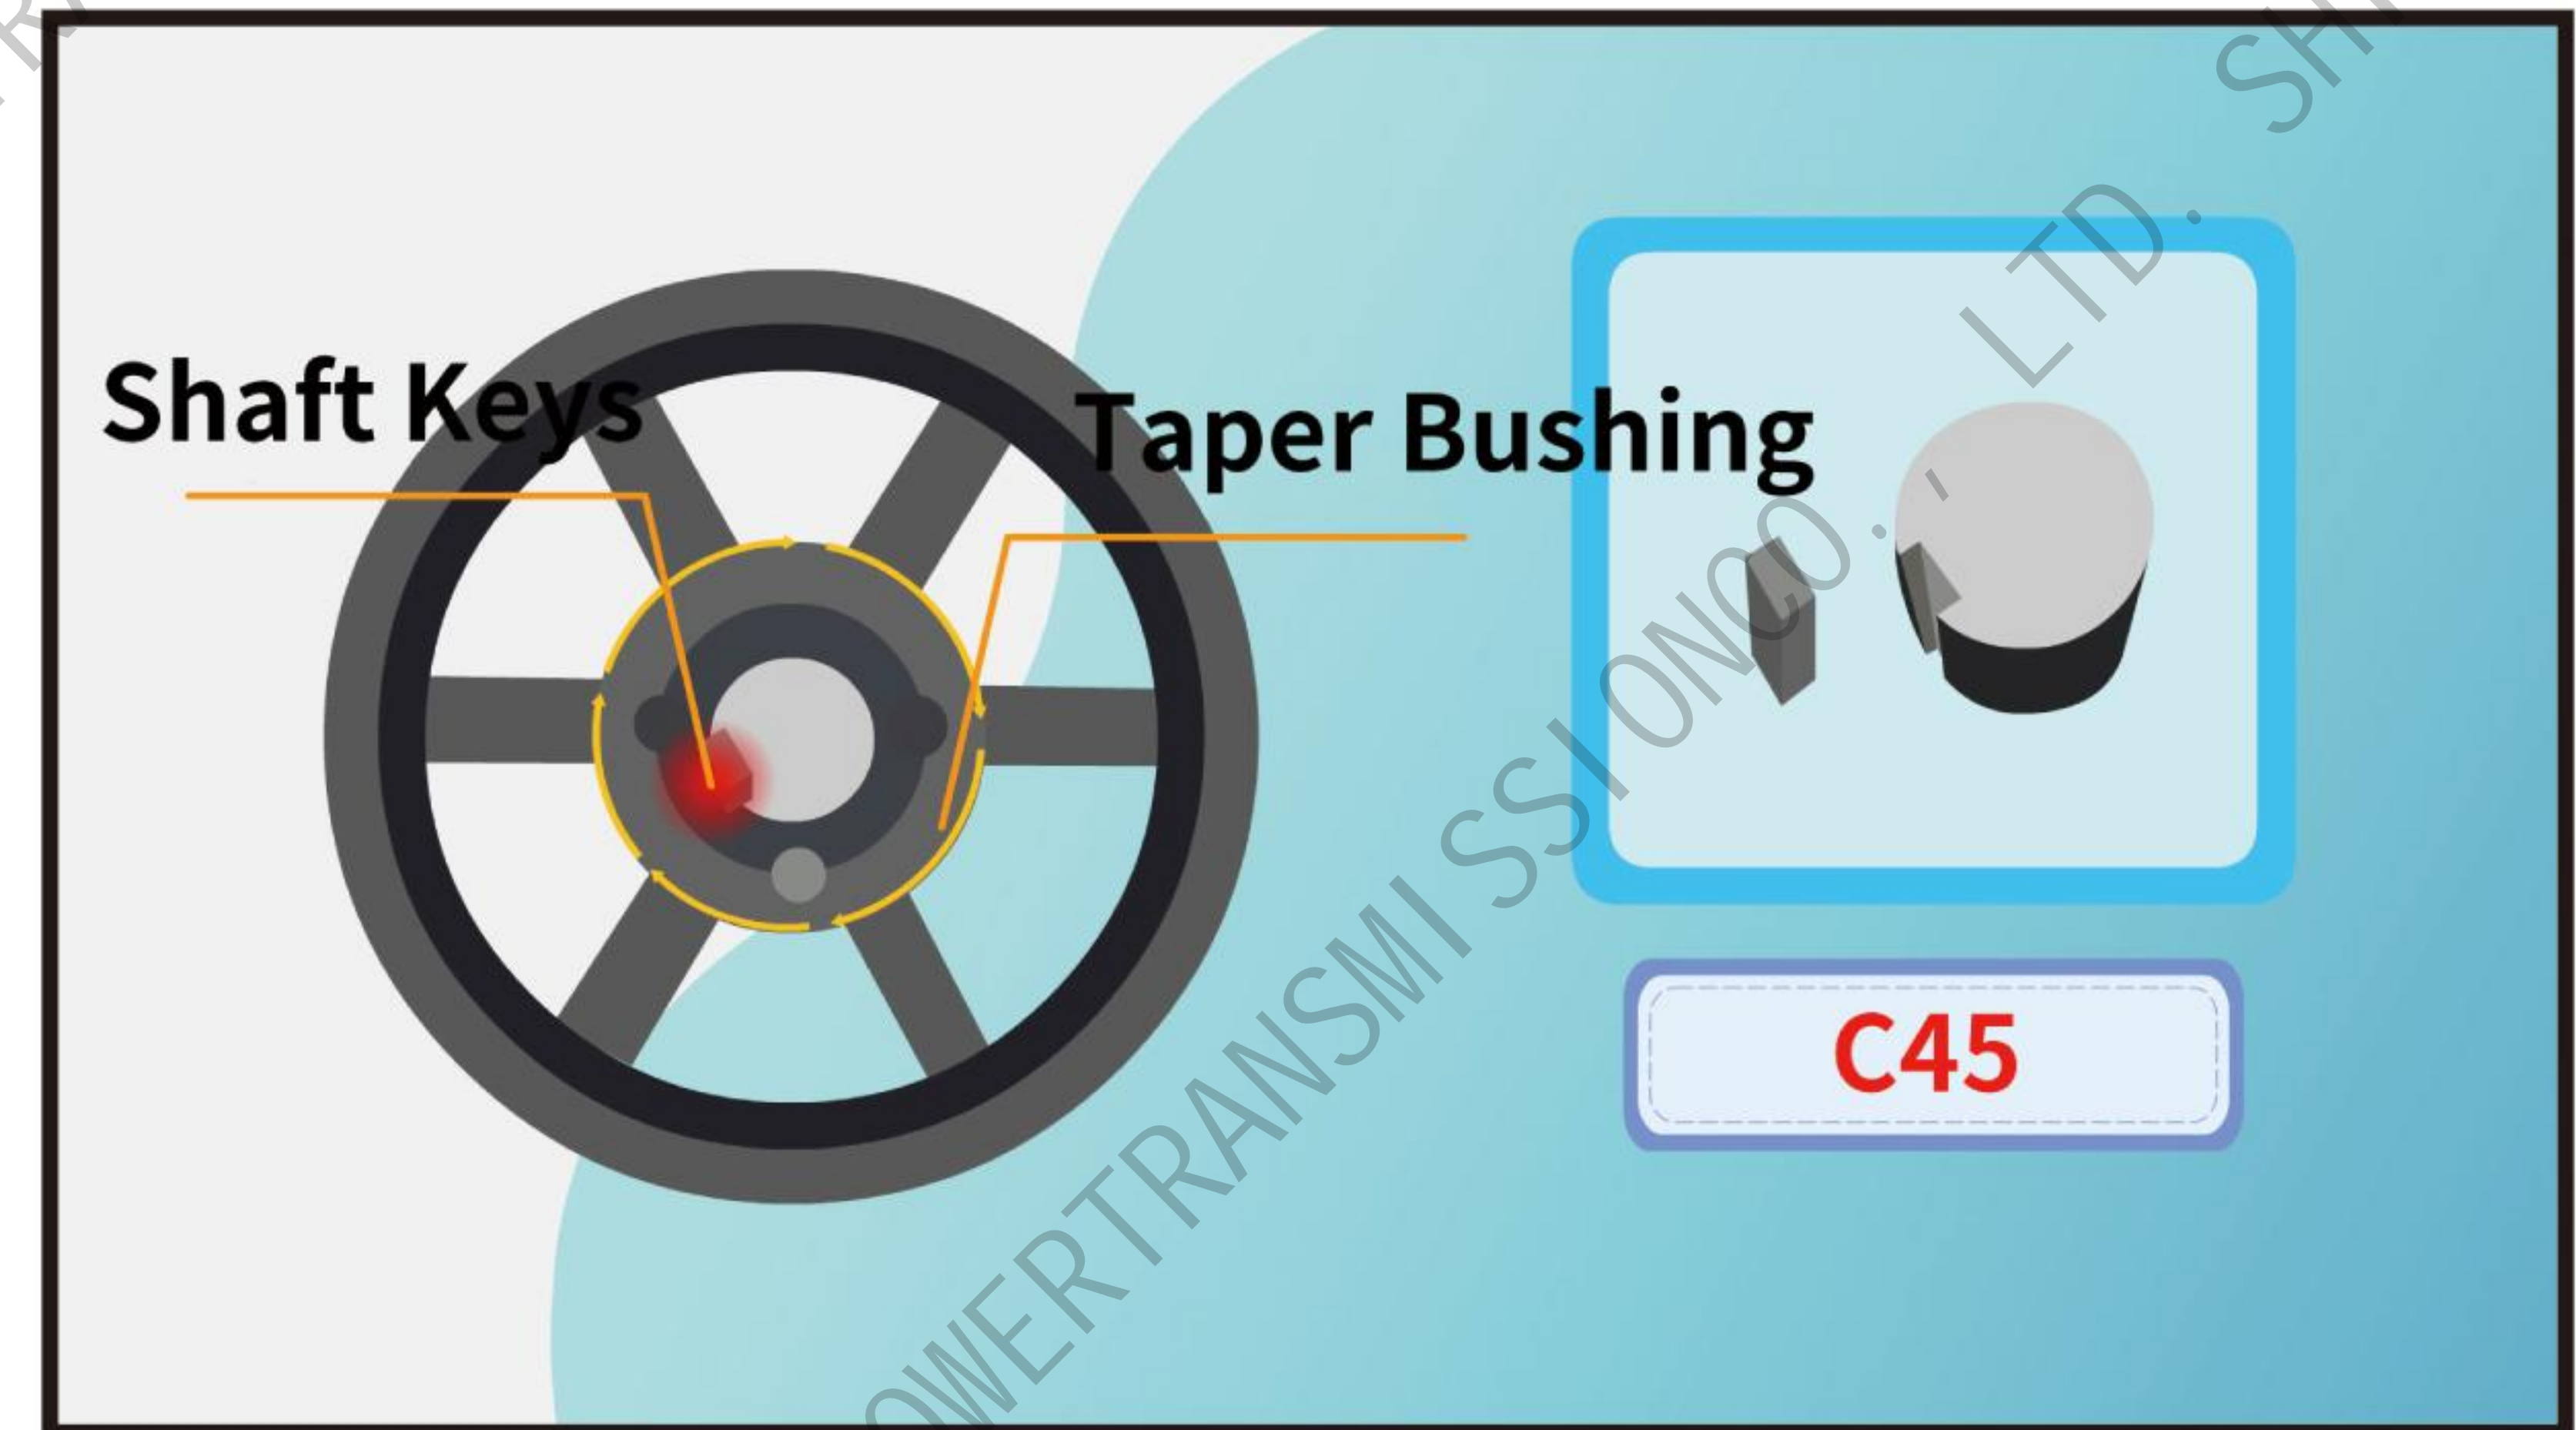
⑧ The tensile strength of C45 steel shaft keys is higher than that of cast iron bushings.

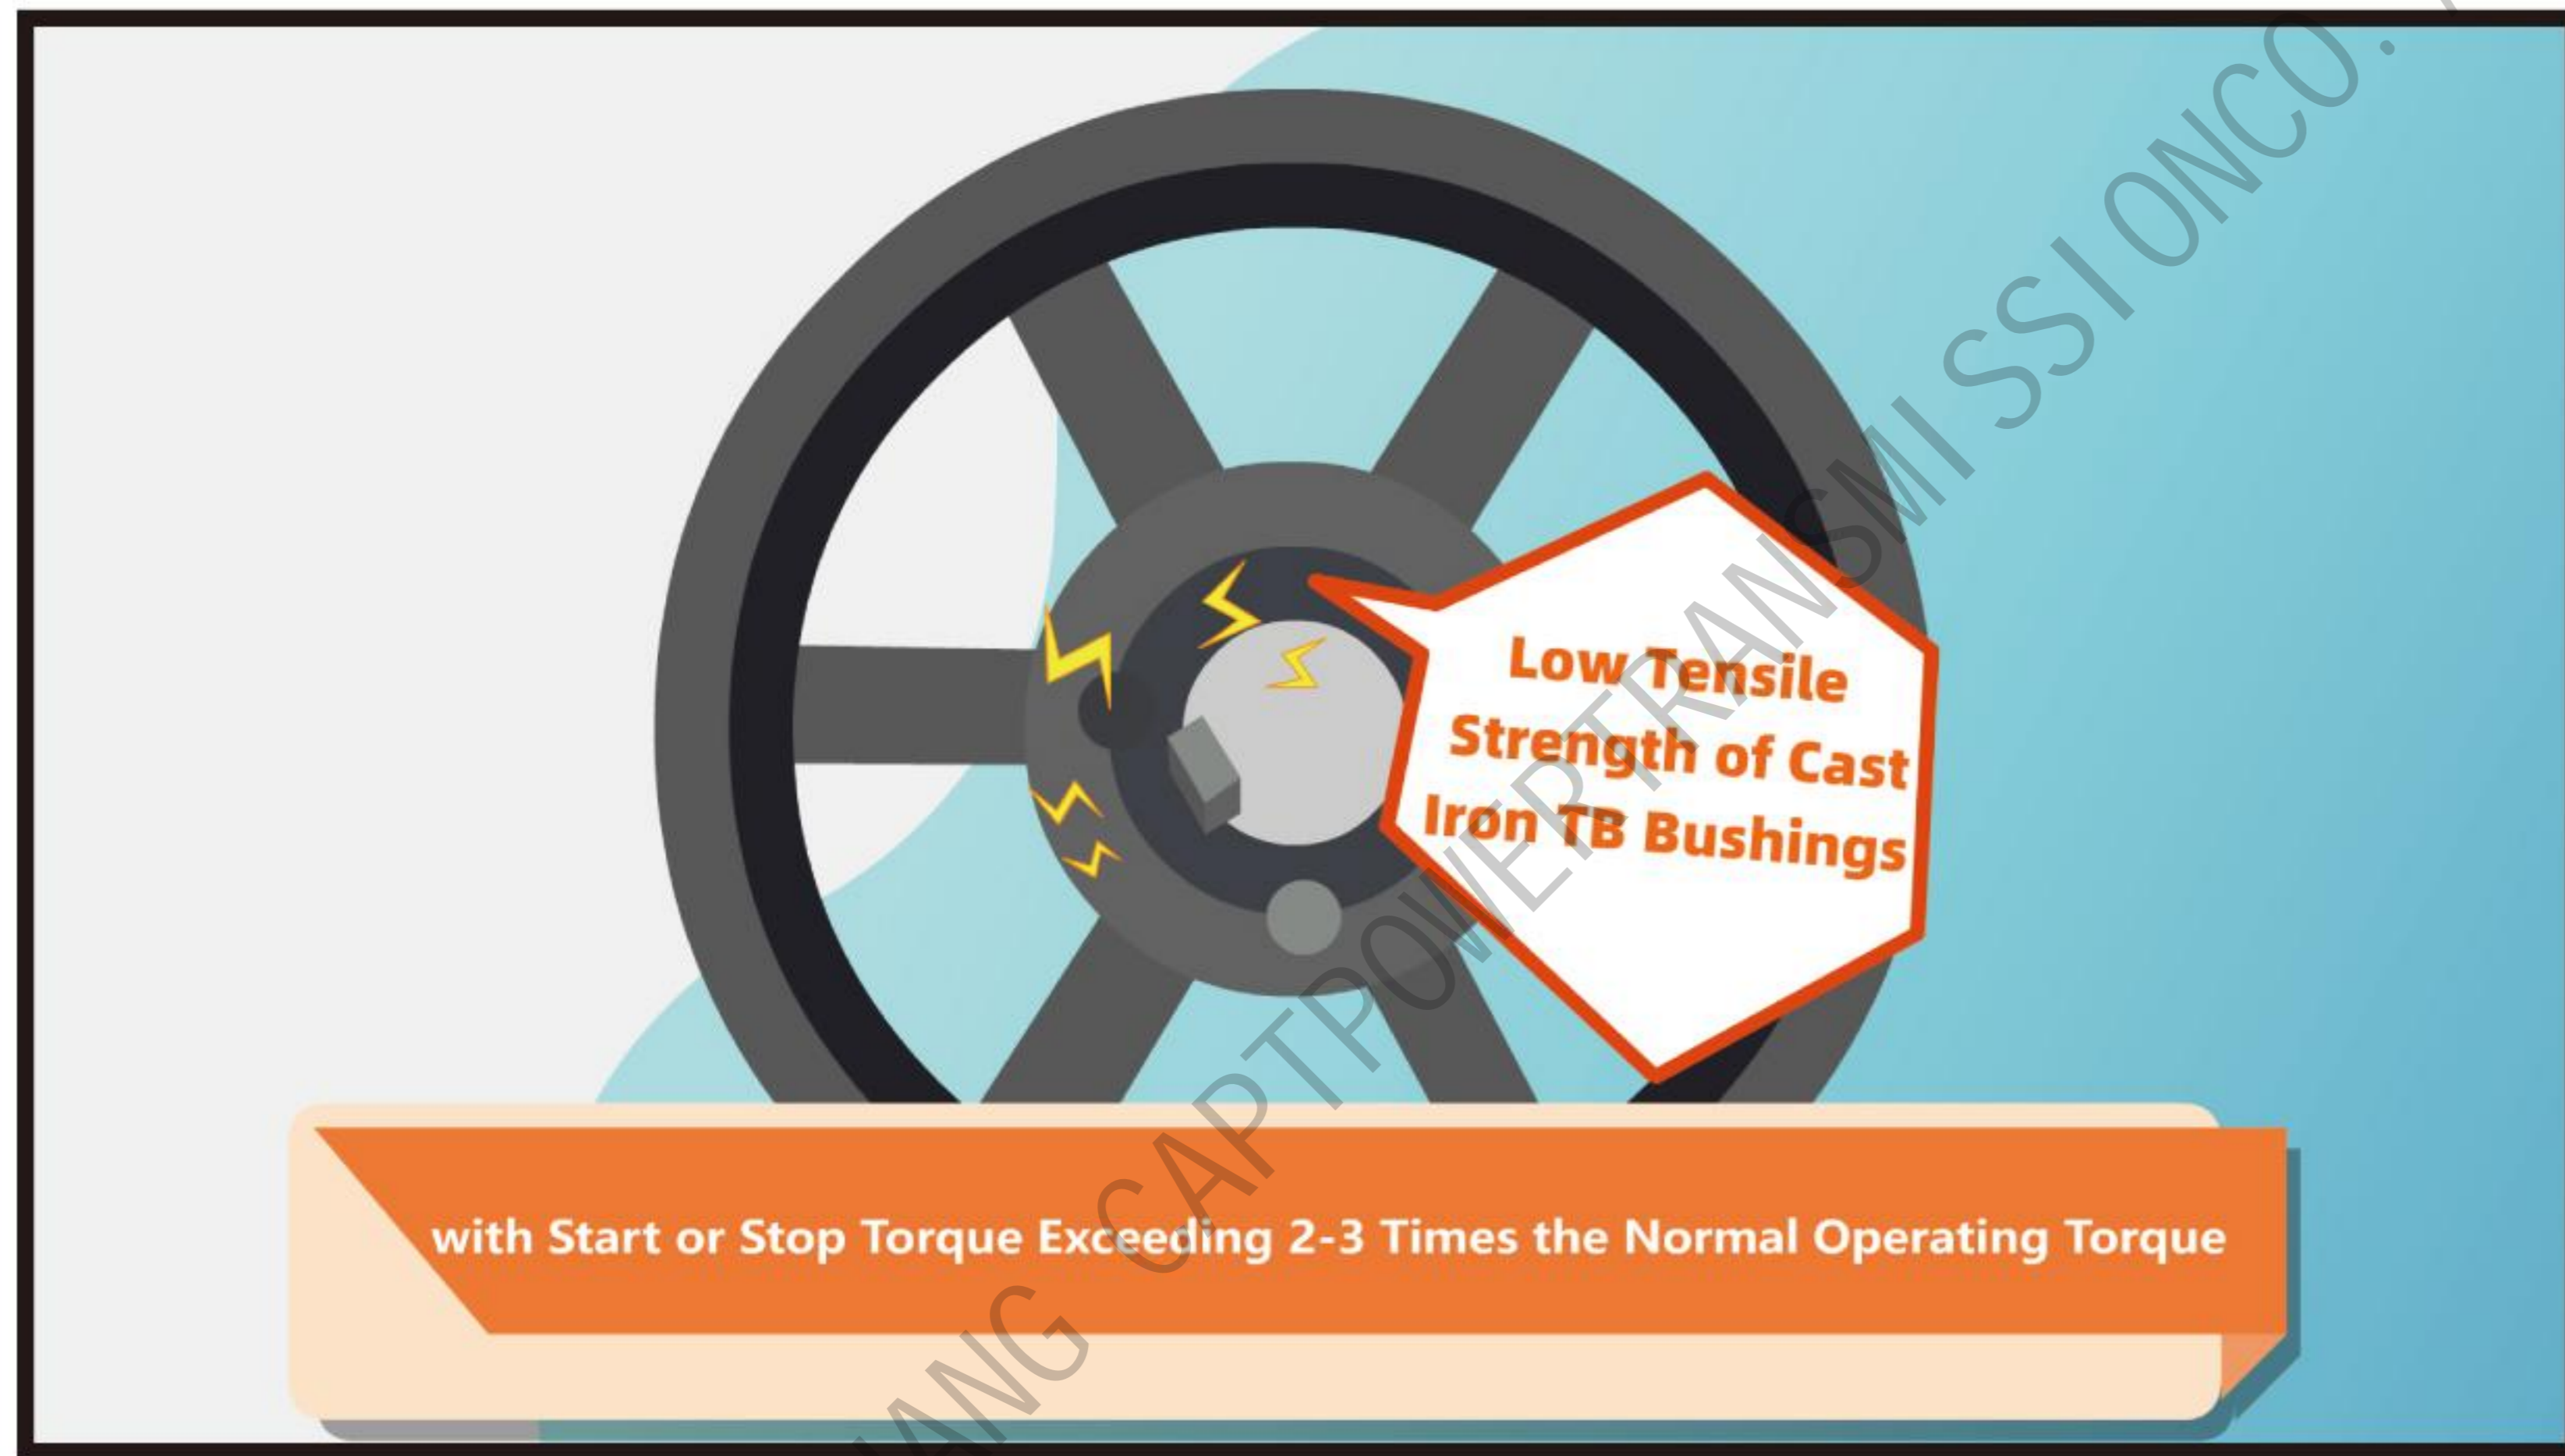
⑨ During operation, strong torque impacts the weak keyway positions.

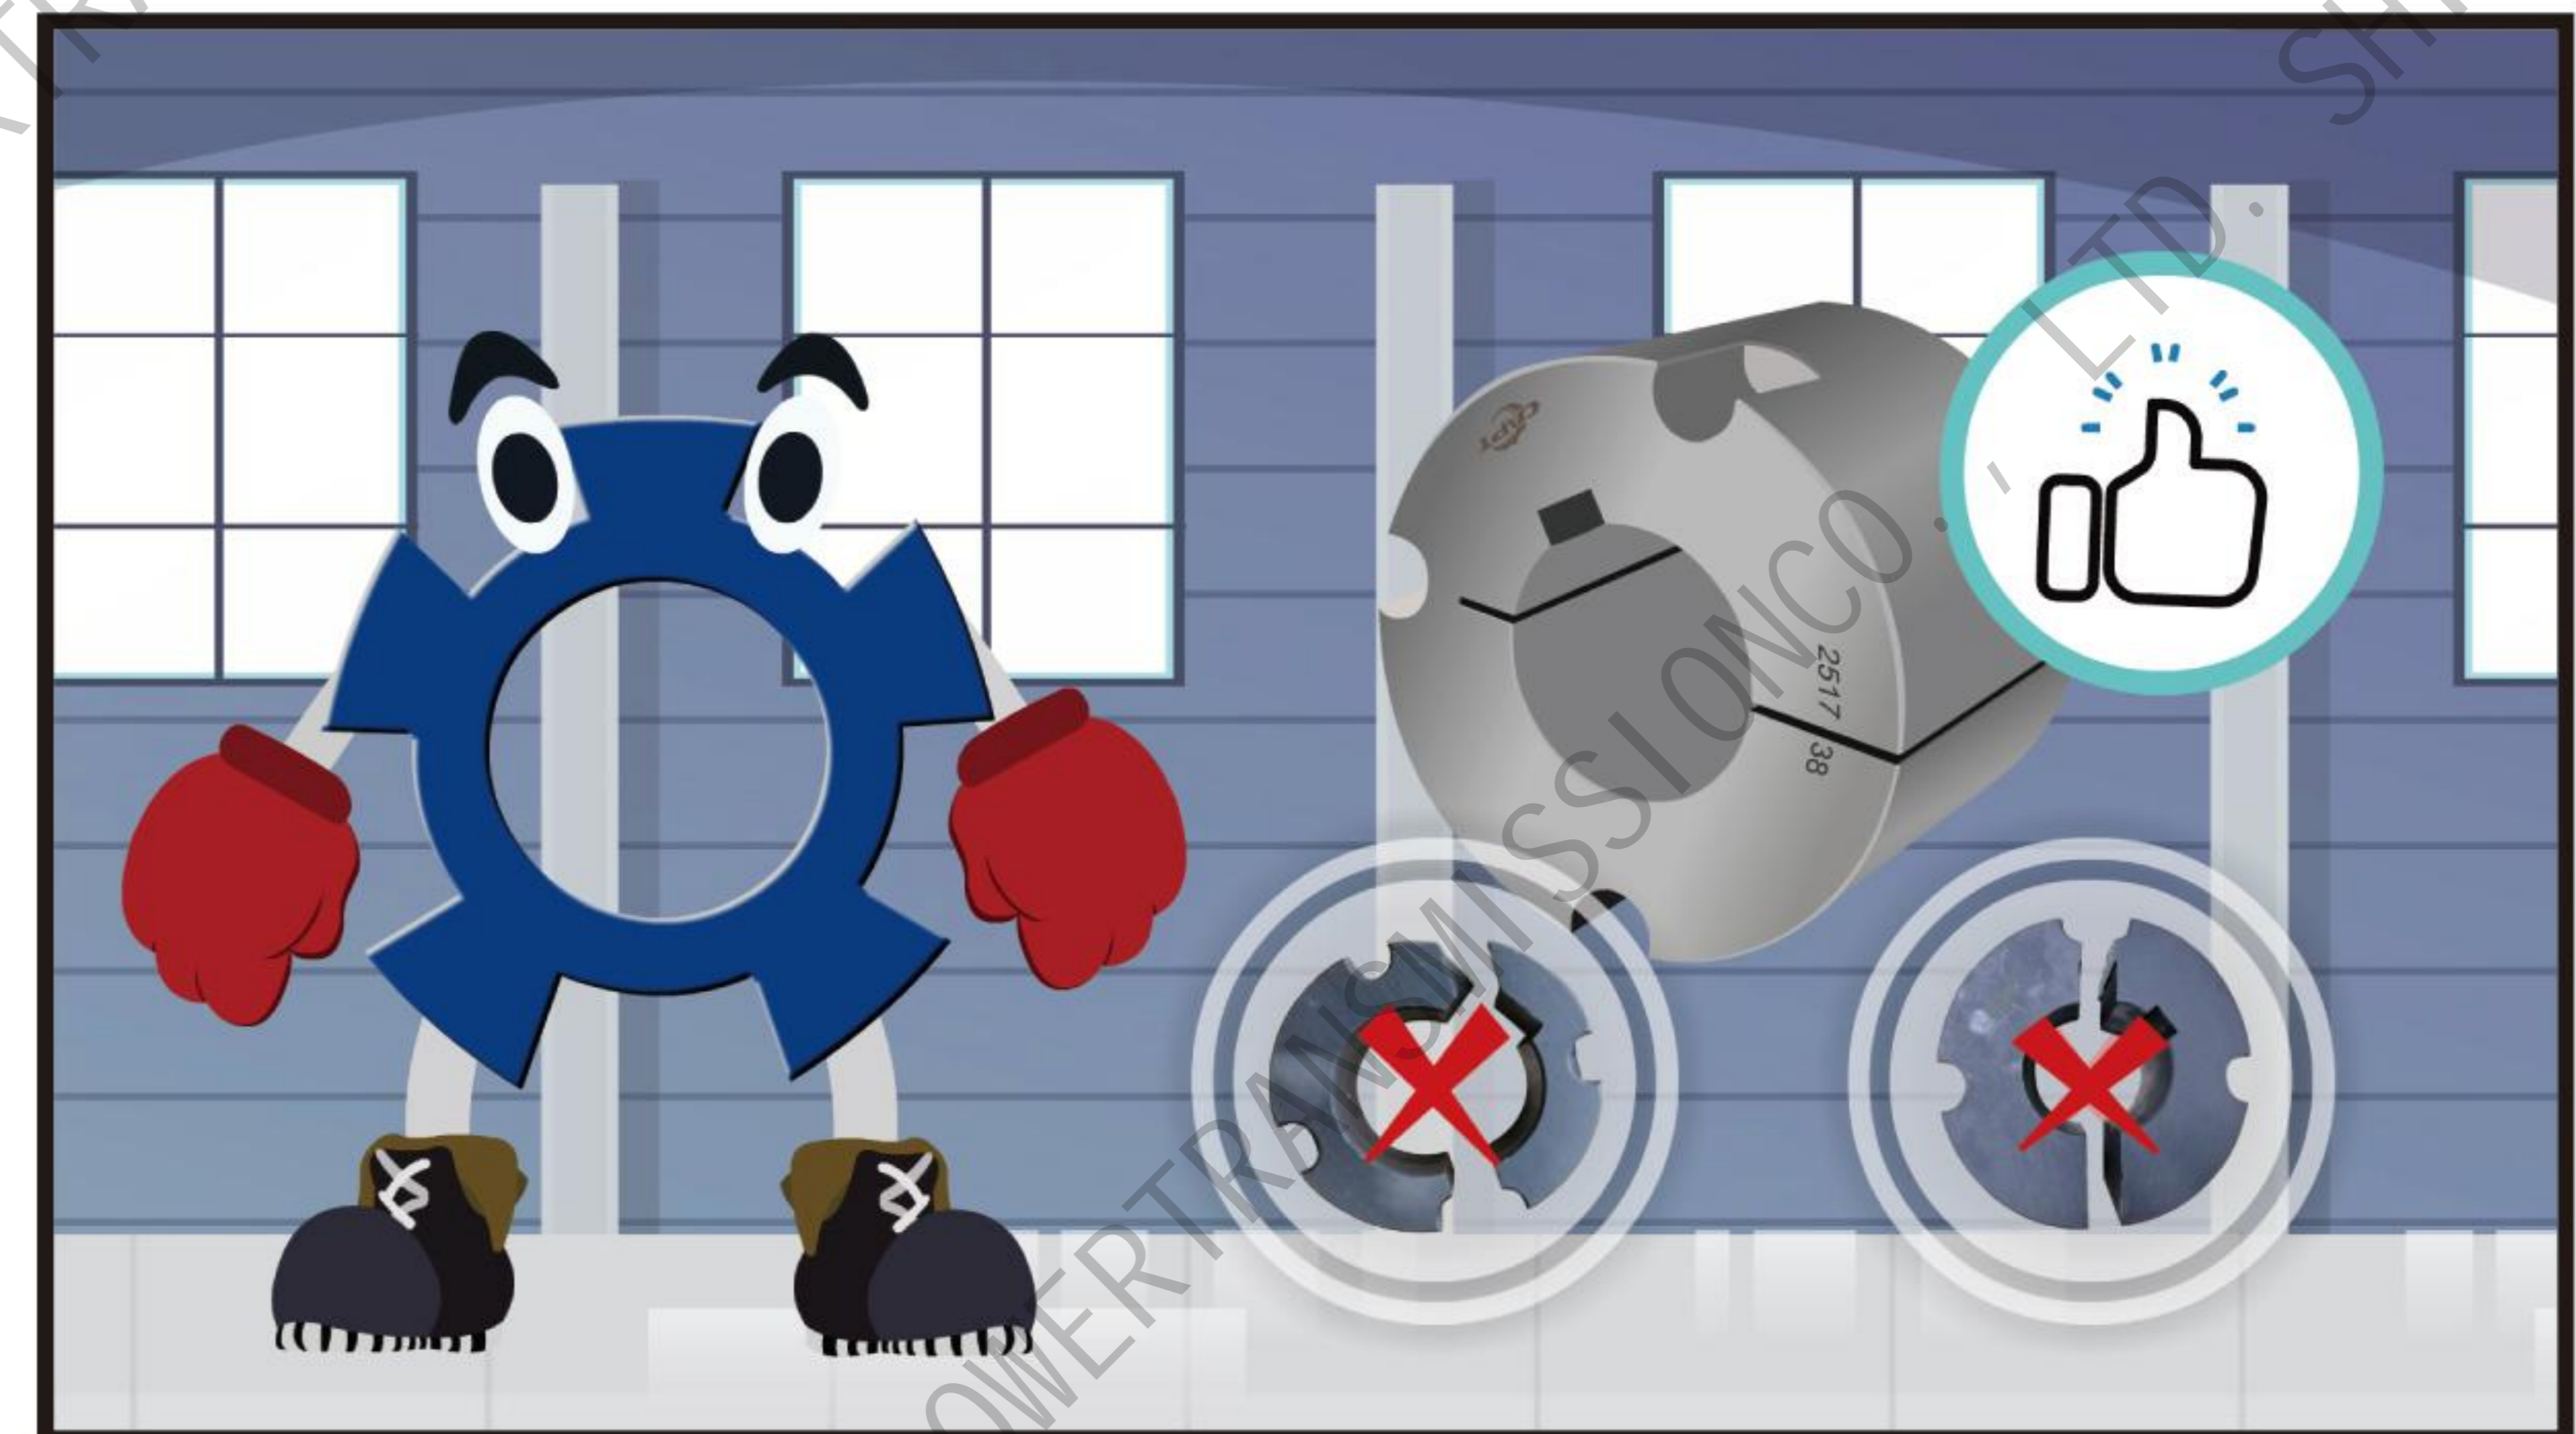
⑫ High-strength C45 steel TB taper bushings can prevent breakage and damage.

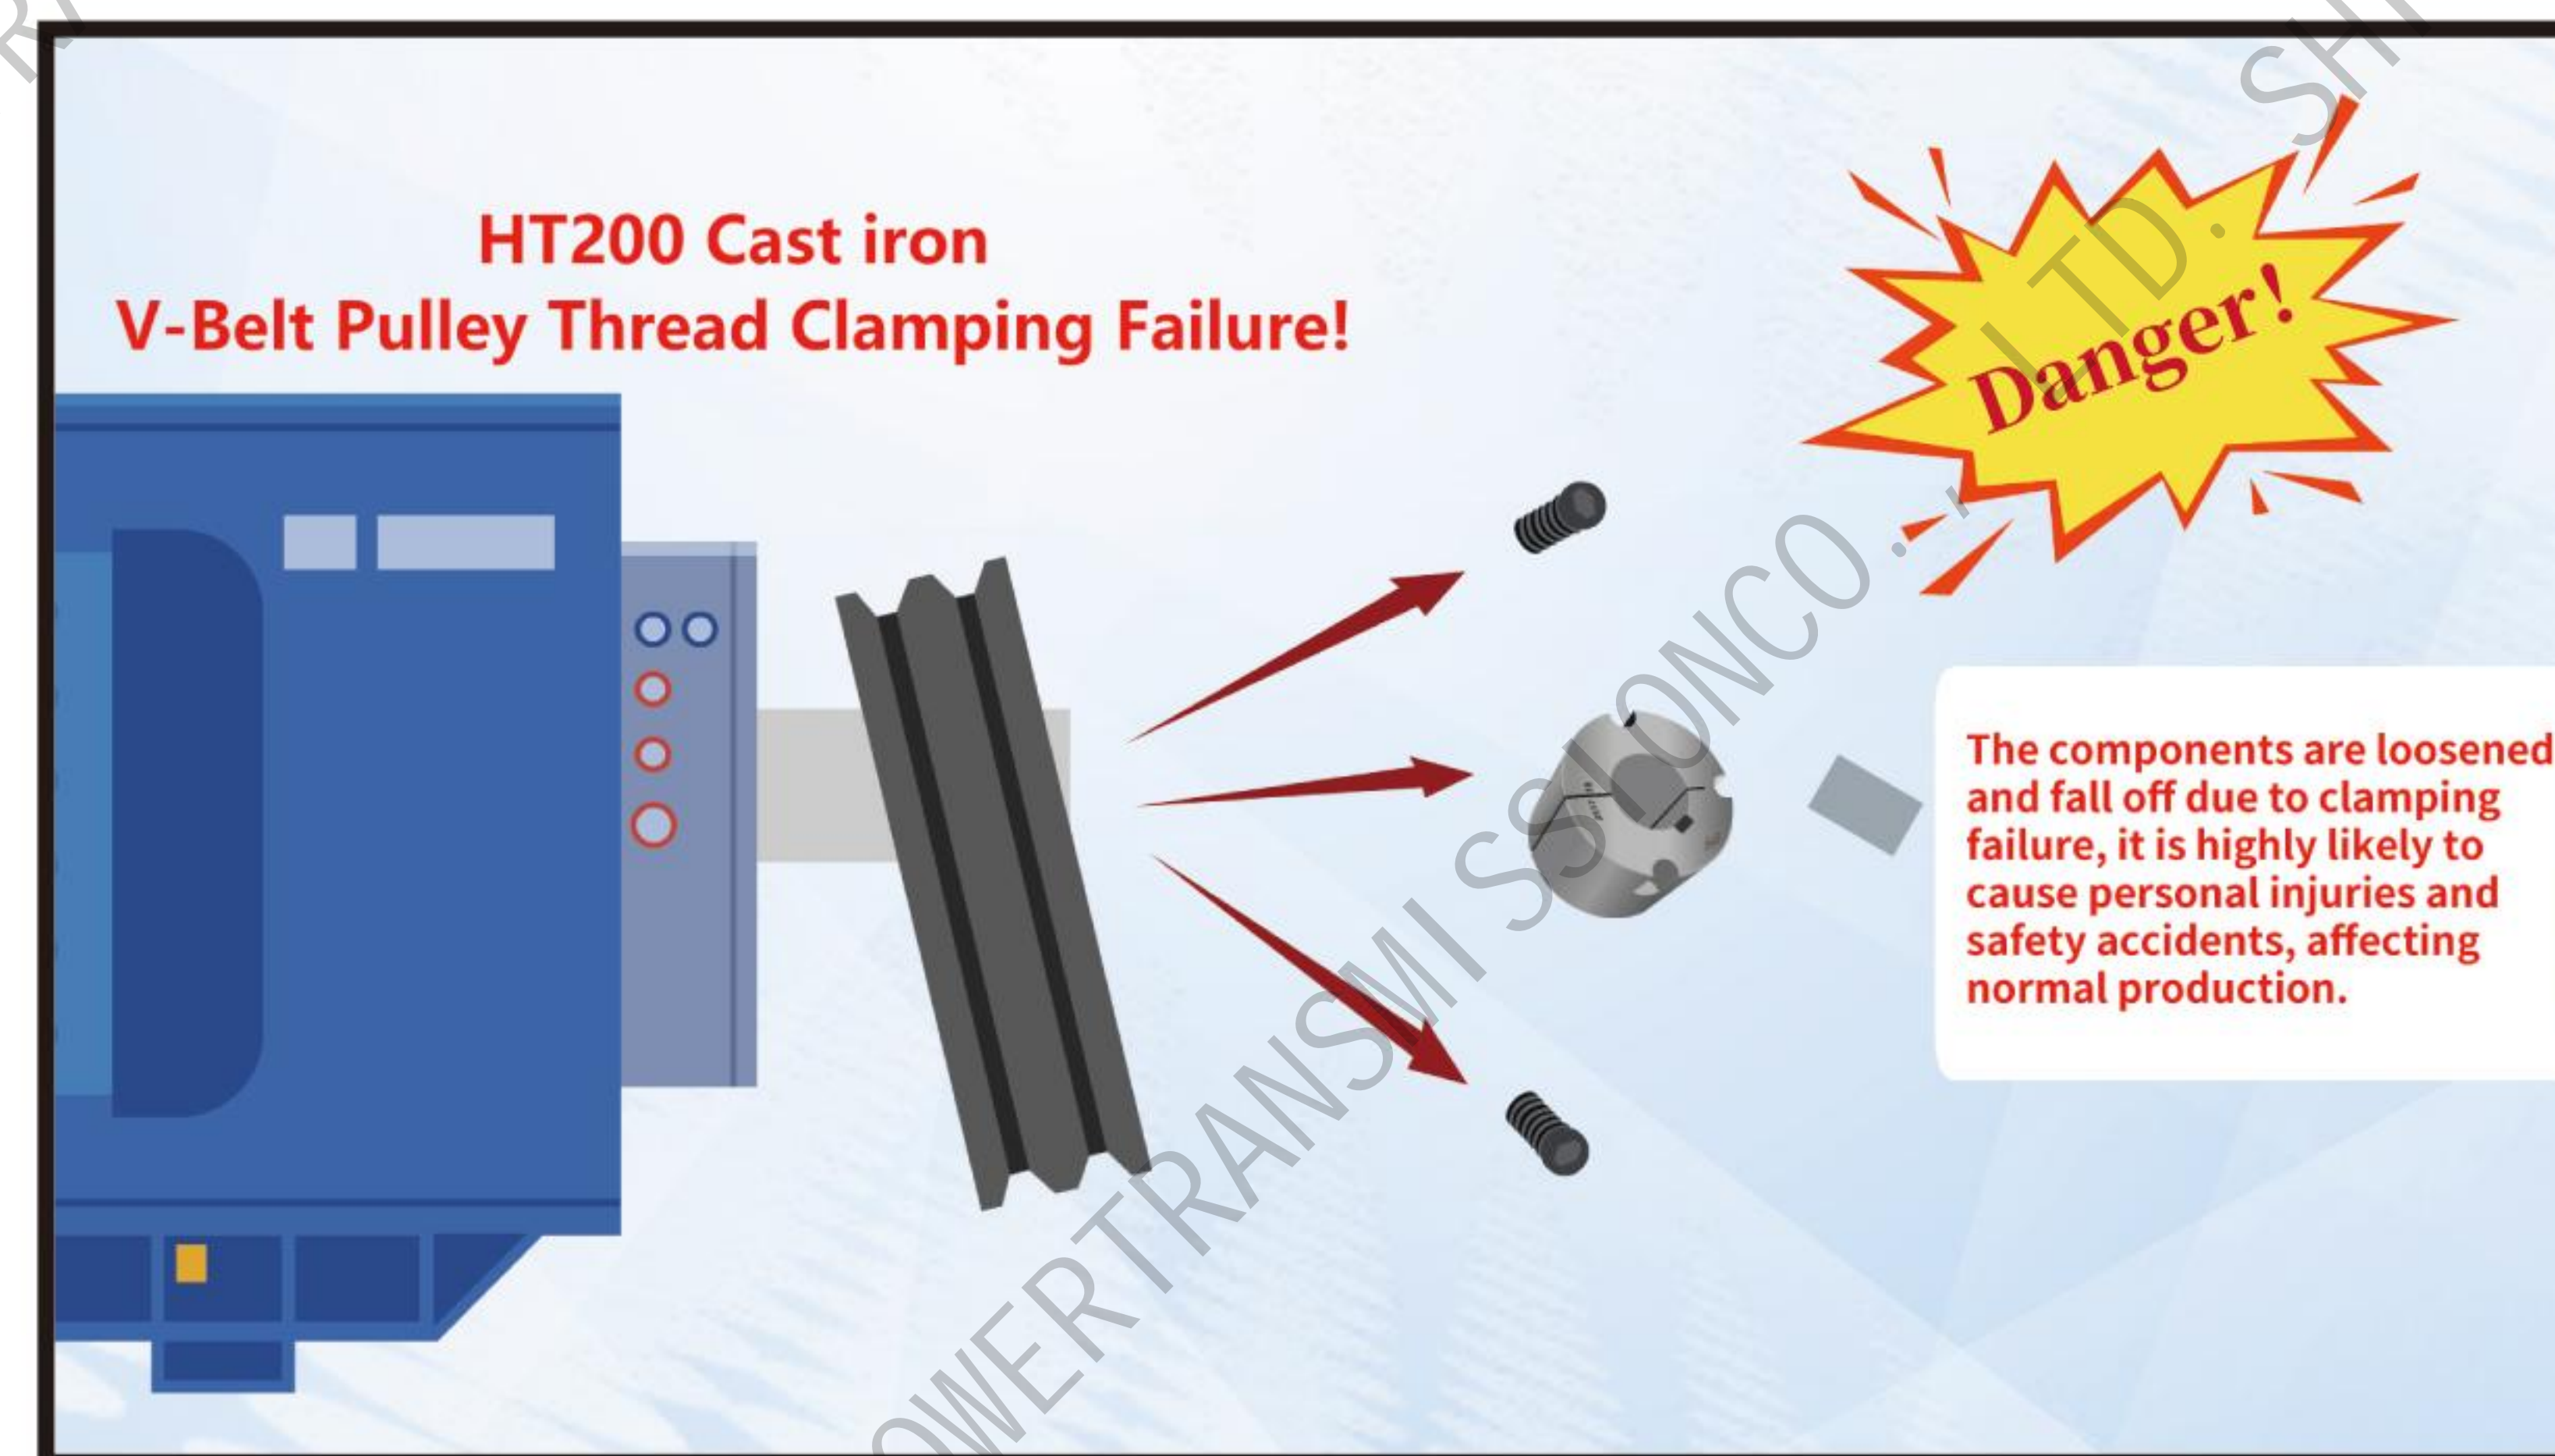
⑯ At high speeds, components may scatter in all directions.

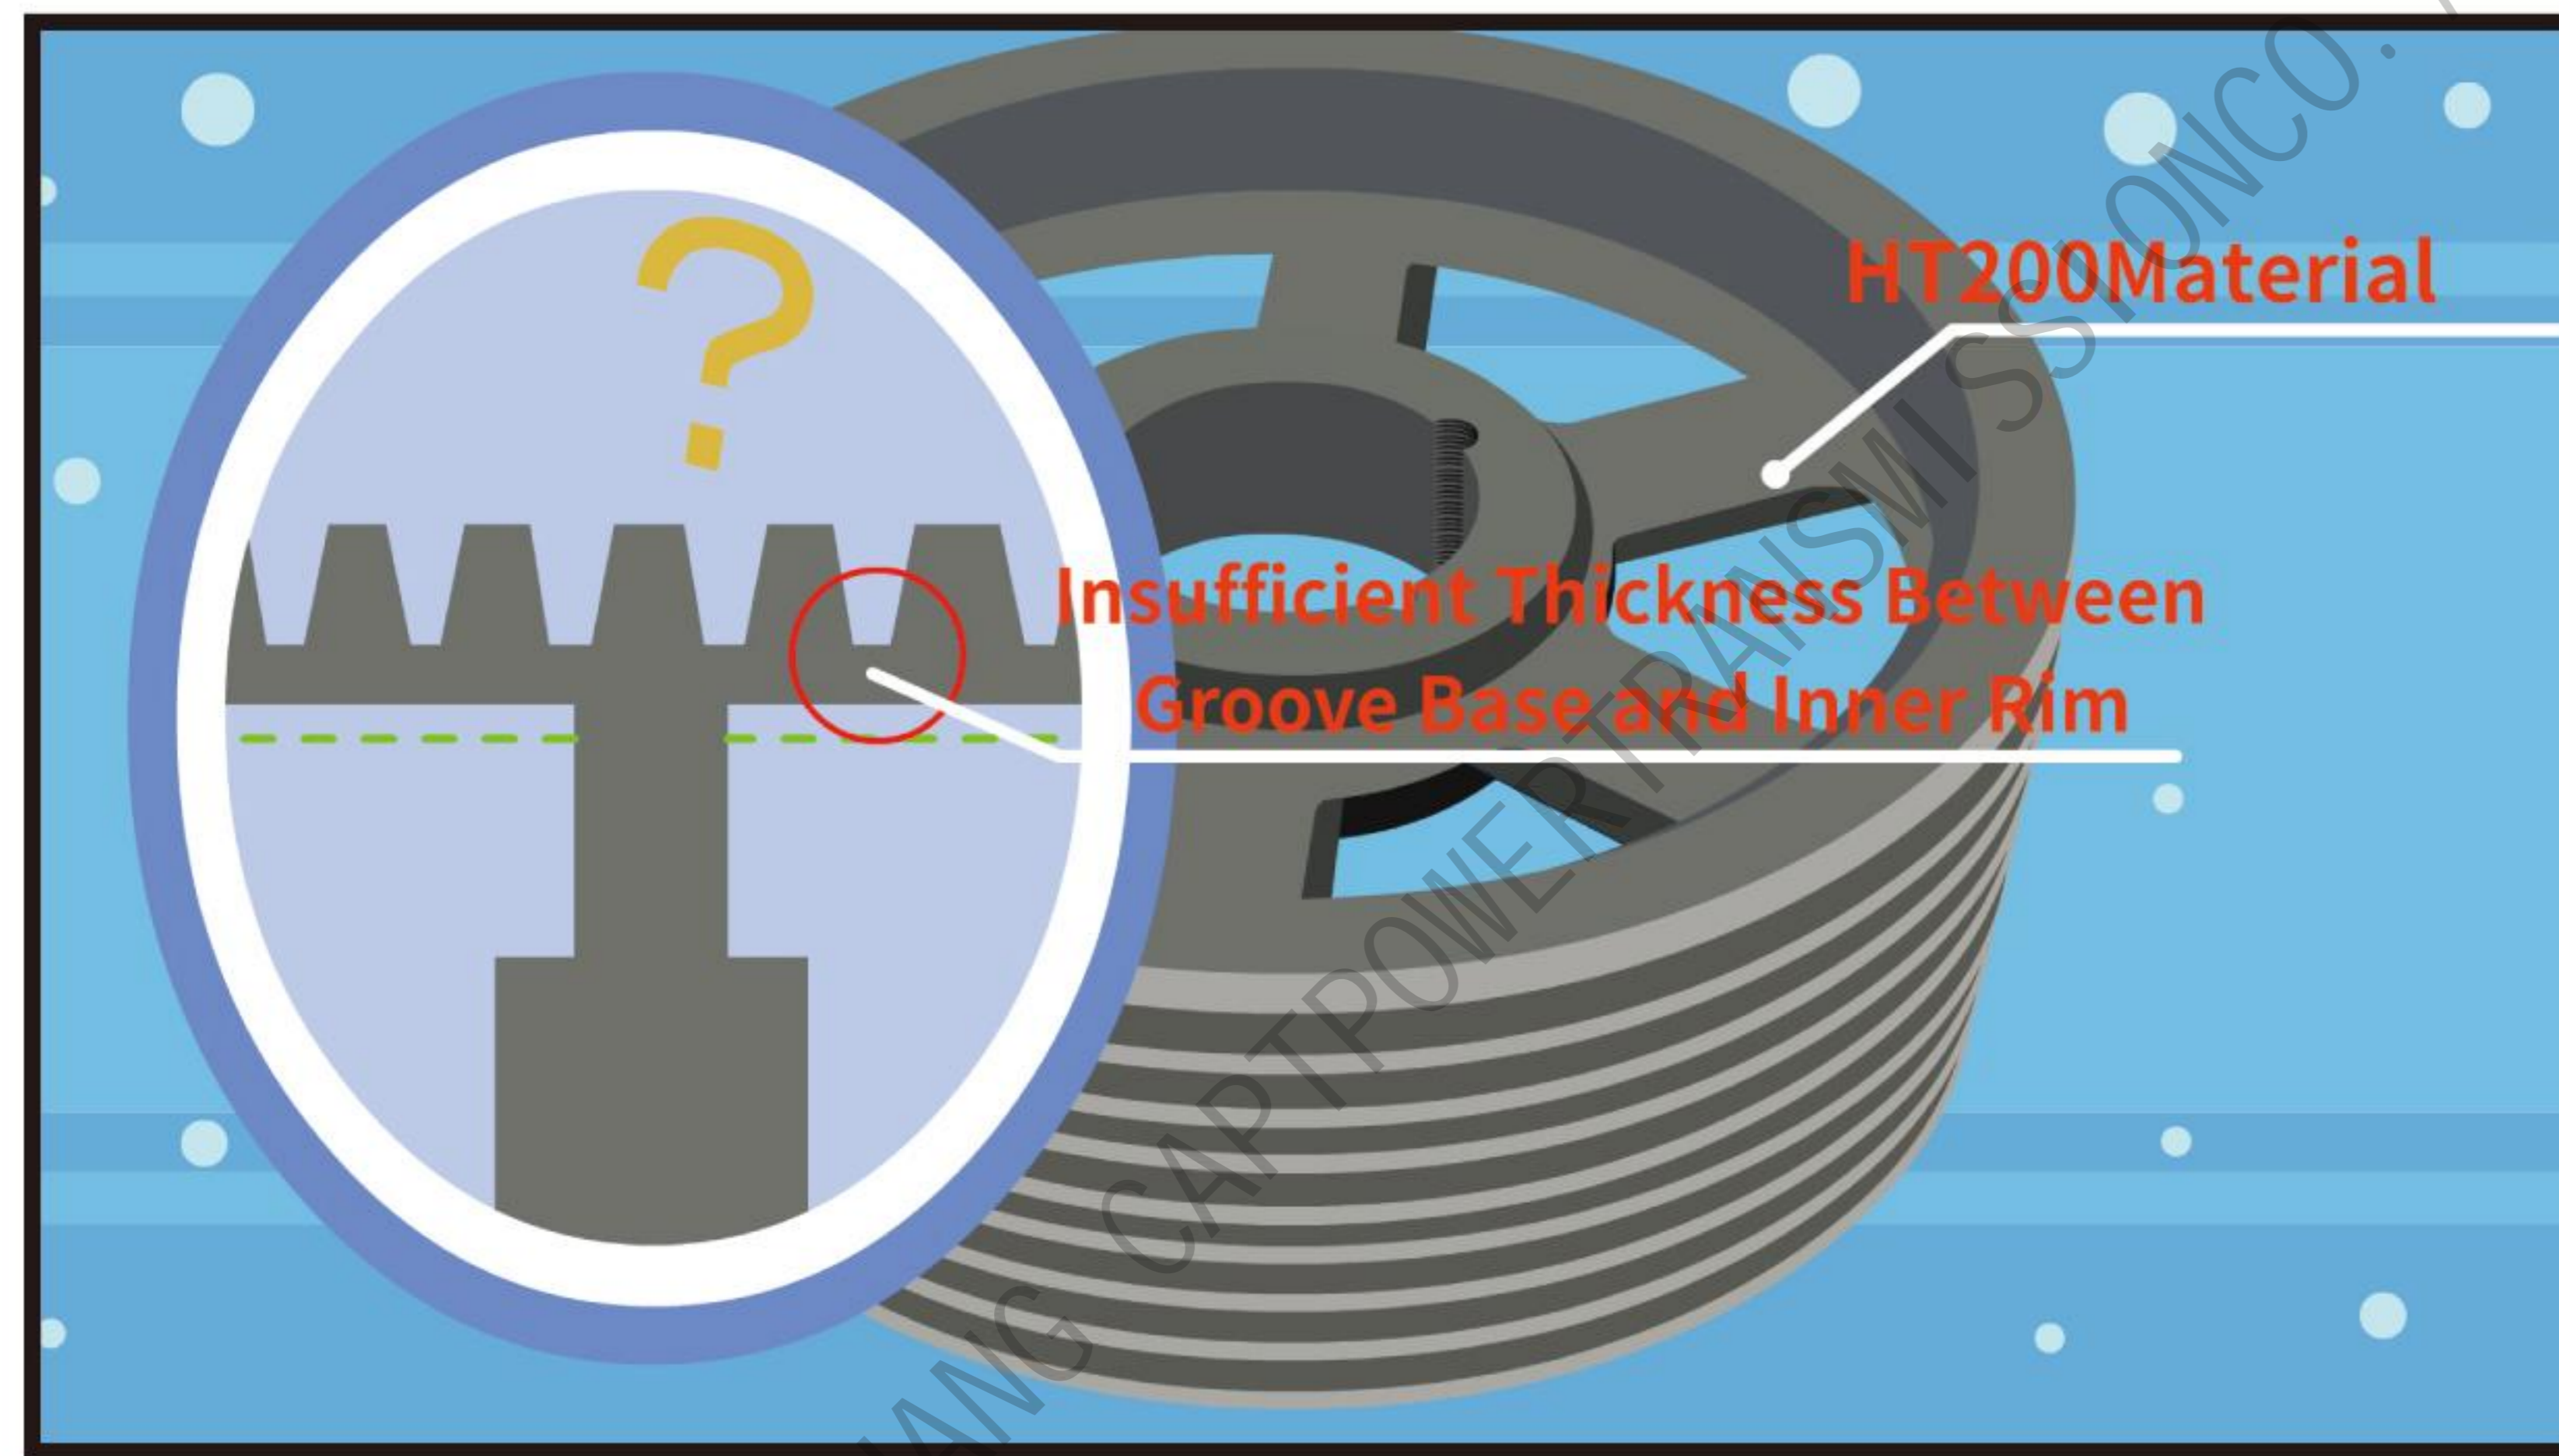
⑰ Over-reduction of rim thickness in multi-groove HT200 cast iron pulleys weakens structural integrity.
